NATIONAL PHOTOGRAPHIC INTERPRETATION CENTER

HOA LAC AIRFIELD

NORTH VIETNAM

ATTACHMENT TO M-6062
20 MARCH 1969
PAGE 1

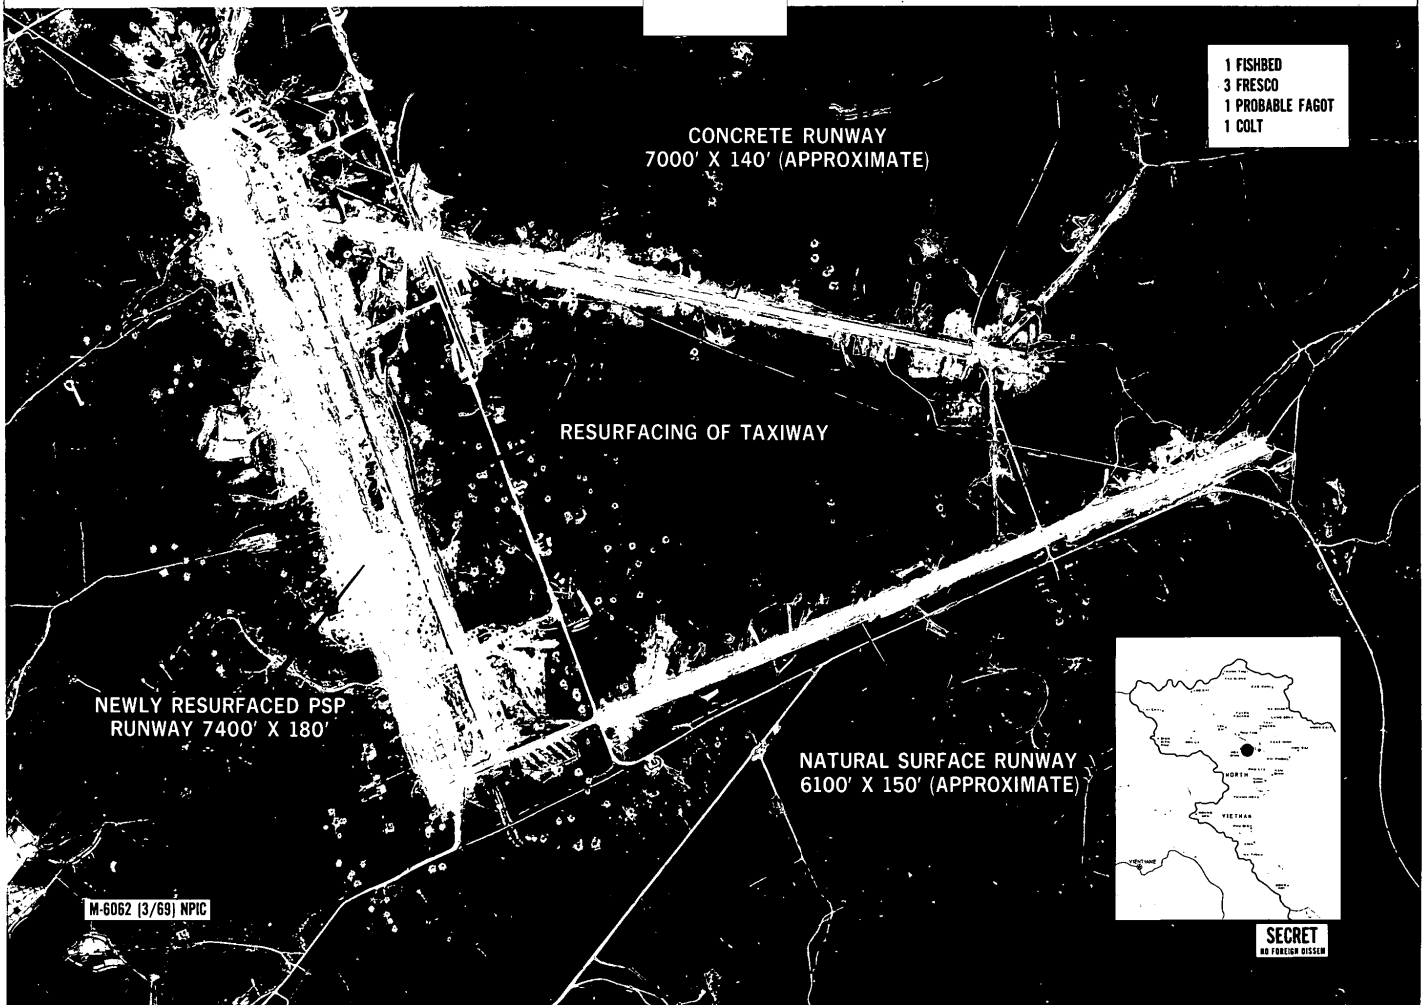
THIS BRIEFING BOARD DEPICTS THE RECENTLY COMPLETED RESURFACING OF THE MAIN RUNWAY, WITH PROBABLE RESURFACING OF THE PARALLEL TAXIWAY IN PROGRESS.

PHOTOGRAPHY [REDACTED] REVEALS THAT THE MAIN (NW/SE) RUNWAY HAS BEEN RESURFACED WITH PROBABLE PSP. A CENTER SECTION OF THE PARALLEL TAXIWAY IS APPARENTLY BEING RESURFACED WITH PROBABLE PSP.

POSSIBLE PSP SECTIONS ARE OBSERVED ALONG THE EDGE OF THE TAXIWAY. NEW RUNWAY MARKINGS ARE OBSERVED ON THE MAIN RUNWAY AND ON THE SECONDARY (EW) CONCRETE RUNWAY. THE NATURAL SURFACE (CONVERTED TAXIWAY) RUNWAY REMAINS UNCHANGED.
